FRESHWATER ASSESSMENT FOR THE REHABILITATION OF THE DISTILLERY ROAD BRIDGE OVER THE PLANKENBRUG RIVER, STELLENBOSCH

Distillery Road Bridge
Prepared for: AECOM

SLR Project No.: 720.01069.00028

Report No.: 1
Revision No.: 0.1
August 2020

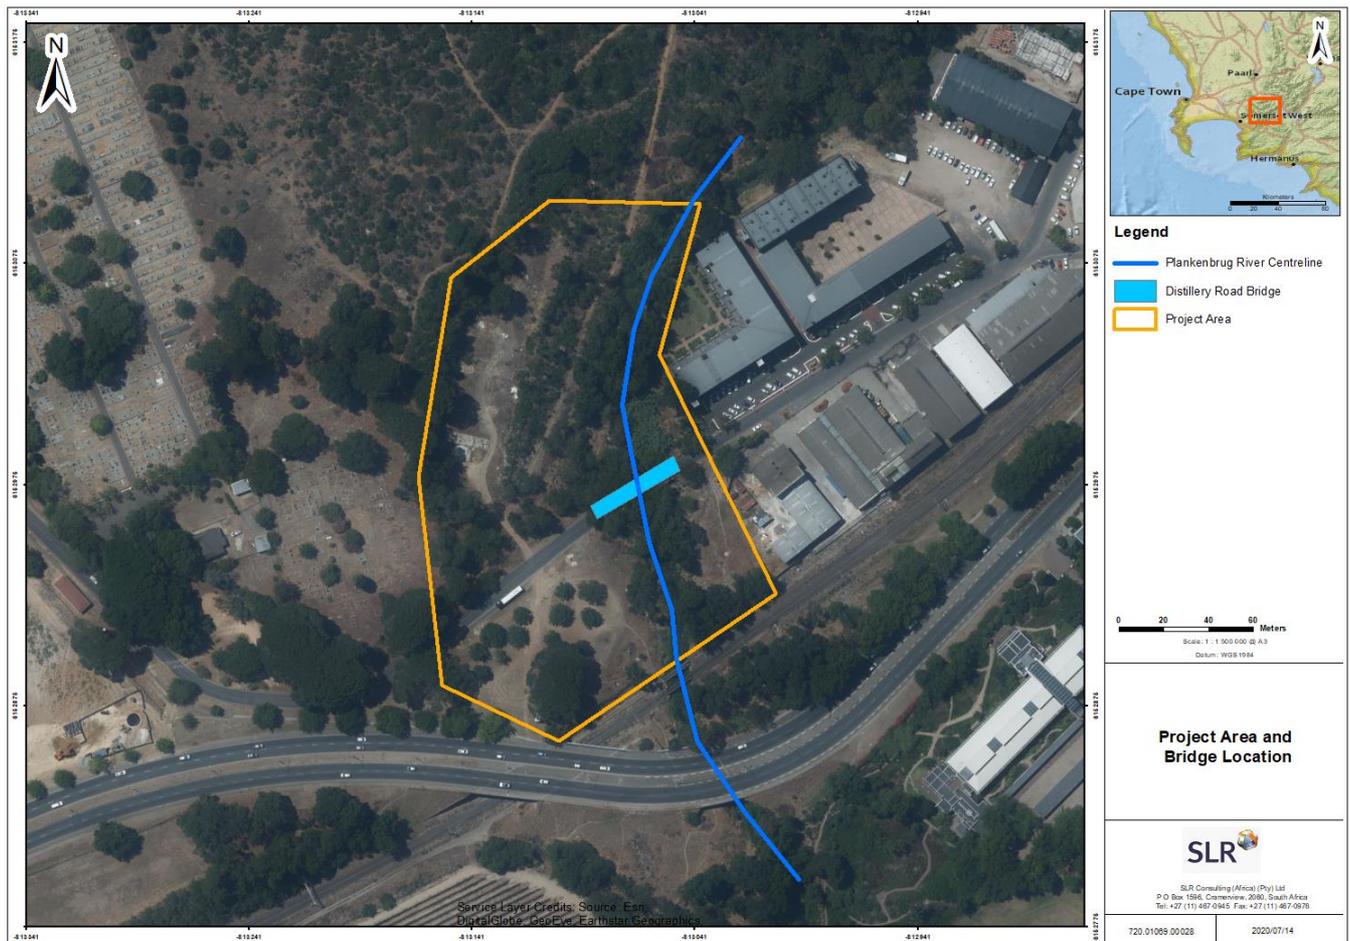
Figure 1-1: Location of the project area and Distillery Road Bridge relative to the Plankenbrug River. The large double lane road near the bottom of the map is Adam Tas Road

Access for bridge construction may be required from both banks of the river, both upstream and downstream of the bridge. A storage/stockpiling, parking and general operational area will also be needed in close proximity to the bridge. An approximate project area has therefore been defined for the purposes of this study that includes the watercourse and both banks of the river, upstream and downstream of the existing bridge, a previously disturbed operational area used in replacement of an adjacent bulk water pipeline, and a reasonable margin surrounding these areas to cater for potential edge effects, covering approximately 2.7ha. Refer to Figure 1-1 below.

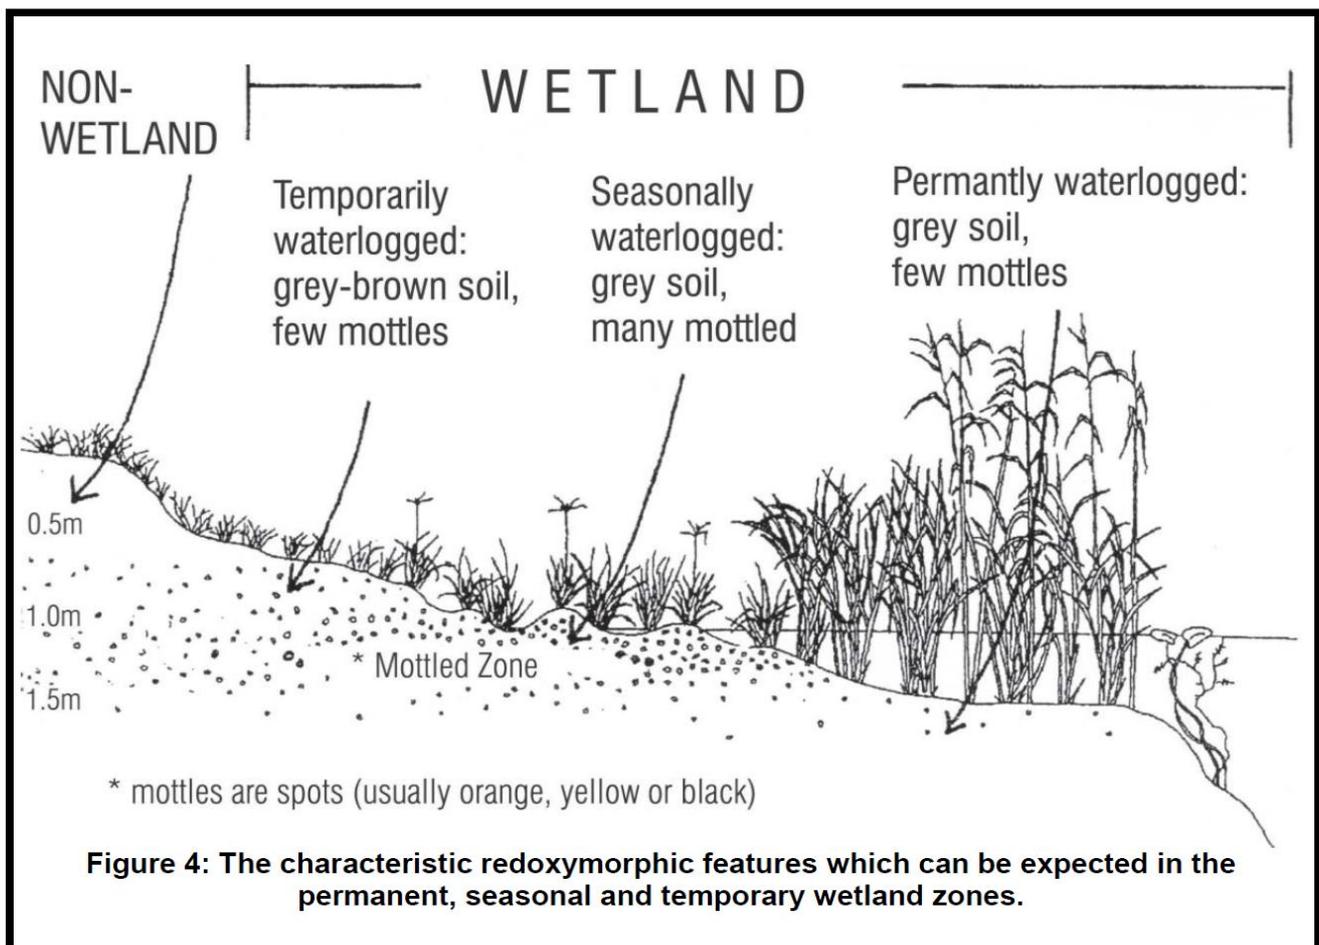
Figure 3-1: A schematic diagram indicating the presence of various indicators in different wetland zones and indicating the wetland boundary (Source: DWAF 2008).

Diagrams of typical cross sections through wetland and riparian habitat and soils extracted from DWAF 2008 are presented in Figures 3-1 and 3-2.

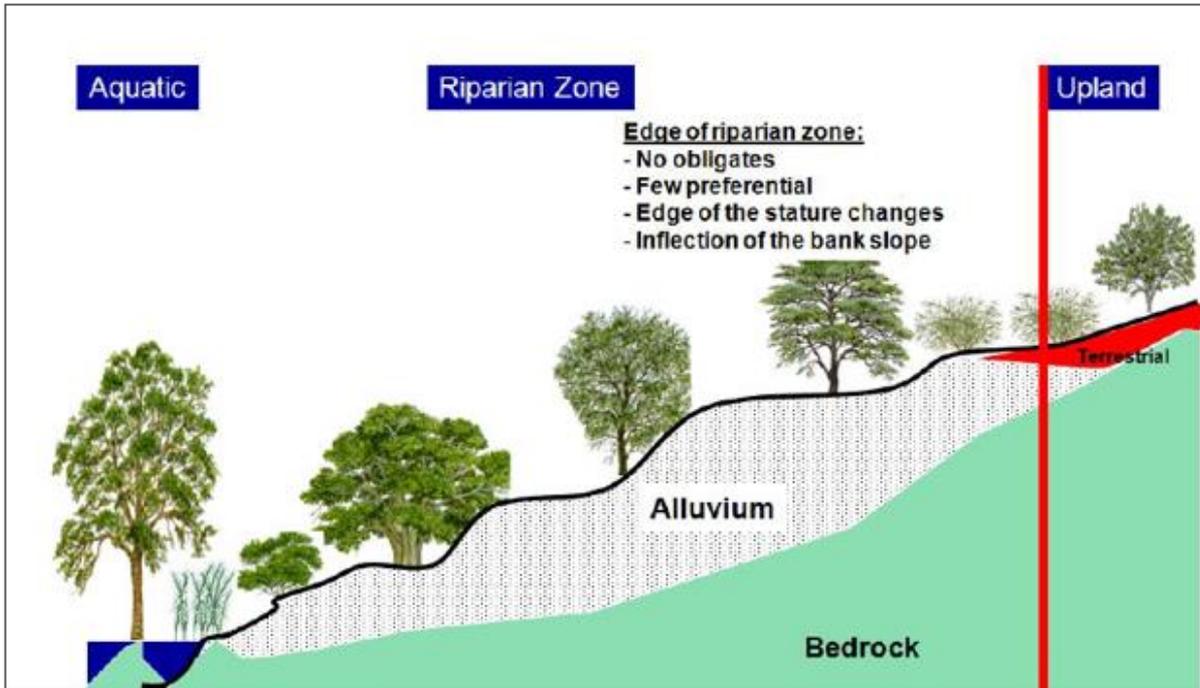
Figure 3-2: A schematic diagram representing the bank and riparian zone of a large river. The boundary between the riparian zone and upland area is indicated (Source: DWAF 2008).

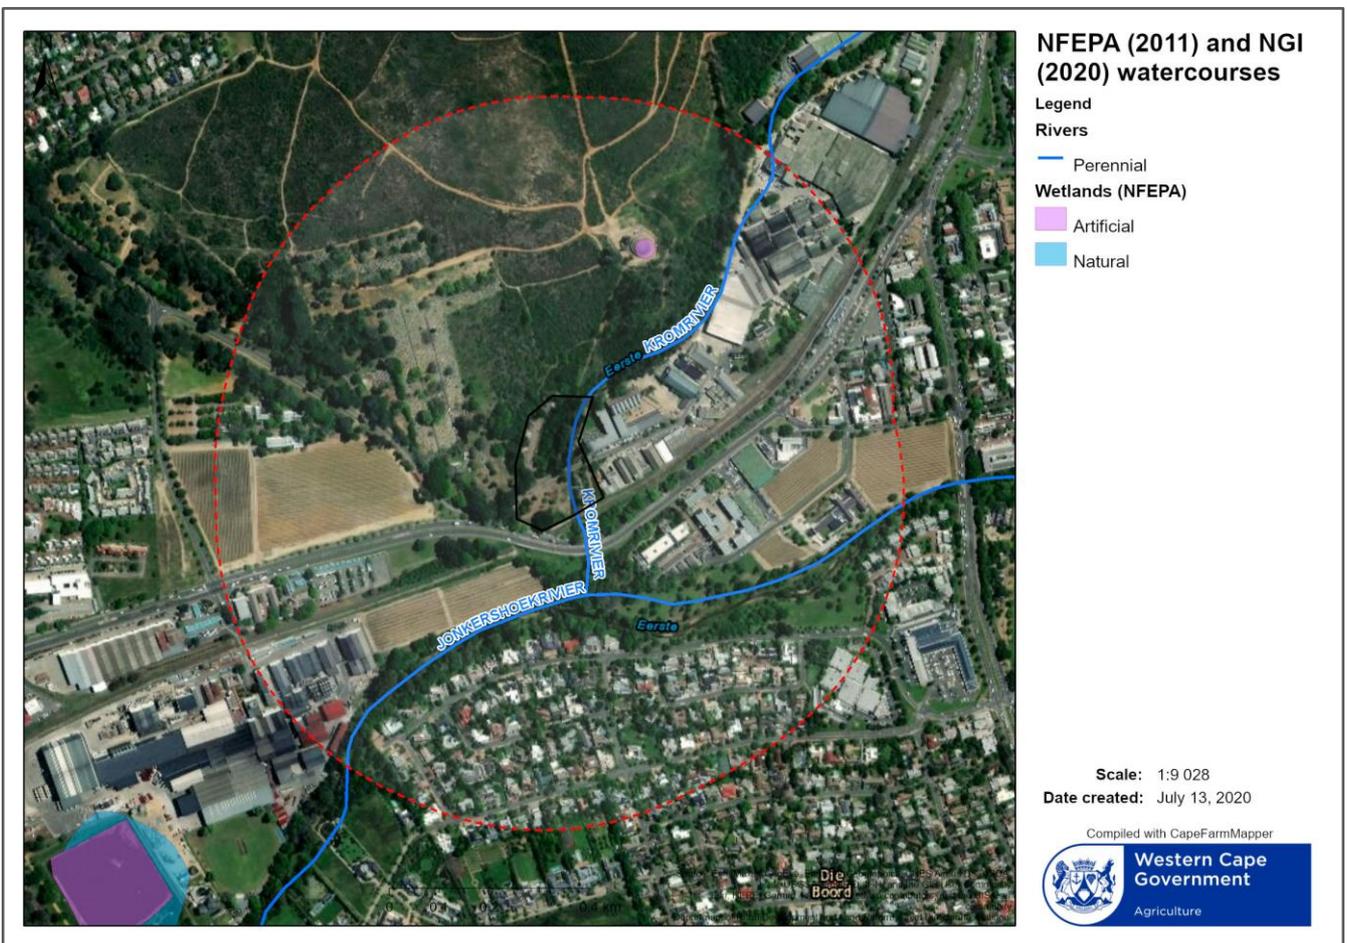
Figure 4-1: NGI rivers and drainage lines are indicated in blue, while NFEPA wetlands are indicated in pink (artificial) and blue (Natural). The project area is indicated in black, and the 500m boundary is indicated by a red dashed line.

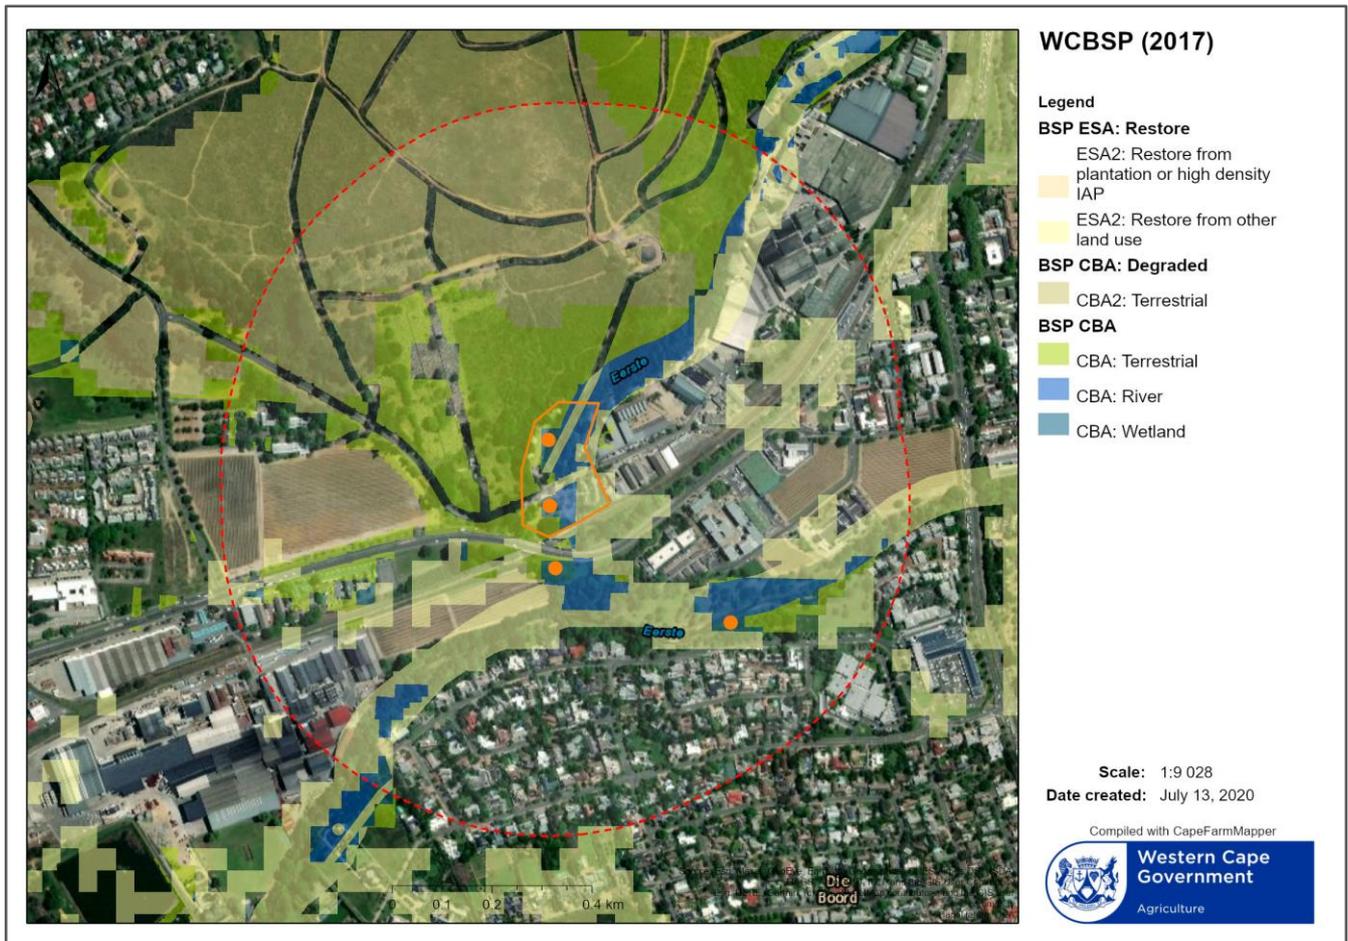
Figure 4-2: The WCBSP (2017) with the project area outlined in orange, the 500 m boundary outlined by a red dashed line and the four wetlands indicated by orange circles.

The WCBS (2017) also indicates areas of CBA1 terrestrial habitat to the west of the river and ESA2 to the east within the approximate project footprint.

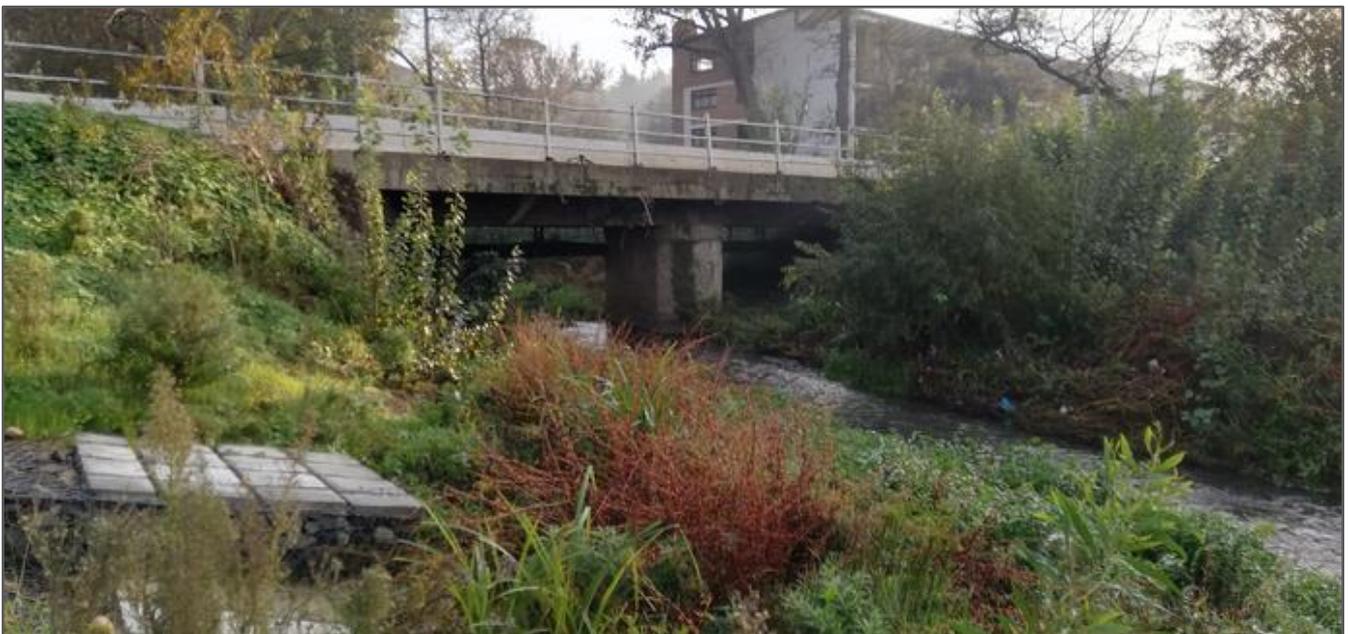
Figure 5-1: The Distillery Road Bridge over the Plankenbrug River.

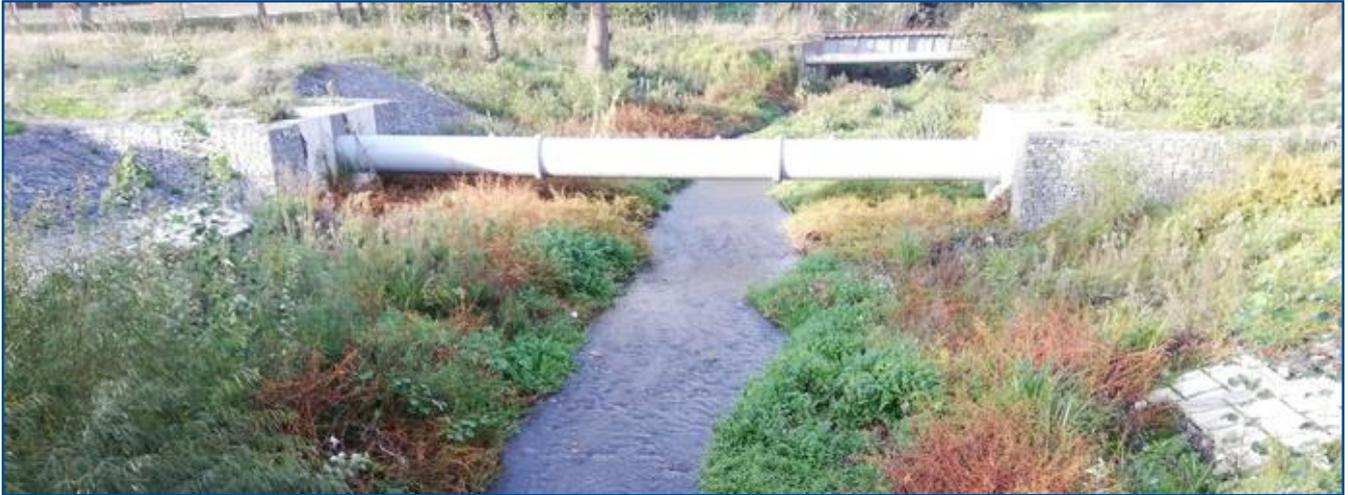
Figure 5-2: The bulk-water pipeline downstream of the Distillery Road Bridge. The railway bridge immediately upstream of the Adam Tas Road bridge is visible in the background.

A site assessment was undertaken on the 5th of June 2020 to determine the nature of the site, the location of the watercourses likely to be impacted and the condition of freshwater habitats. The survey was largely confined to the project area as defined in Section 1.2, but one possible wetland site approximately 140m to the south was also visited briefly. A photograph of the bridge is included in Figure 5-1 below. The project area was found to be largely typical of urban open space with large scale disturbance and general dominance of alien invasive and pioneer vegetation. The recently replaced pipeline was visible downstream of the bridge elevated approximately 2m above the water level in the river (see Figure 5-2).

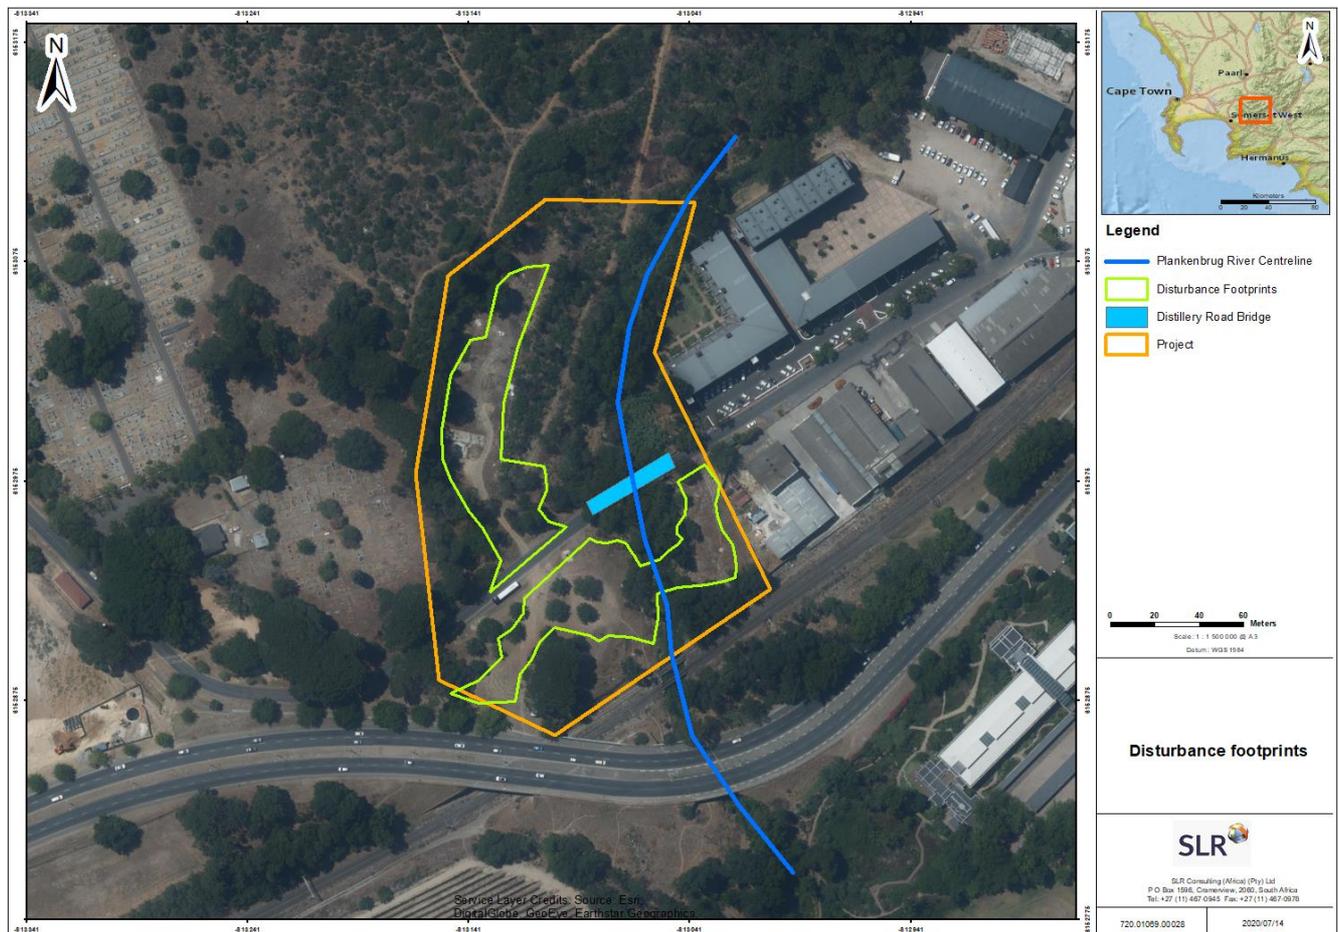
Figure 5-3: Cleared, compacted areas within the project area.

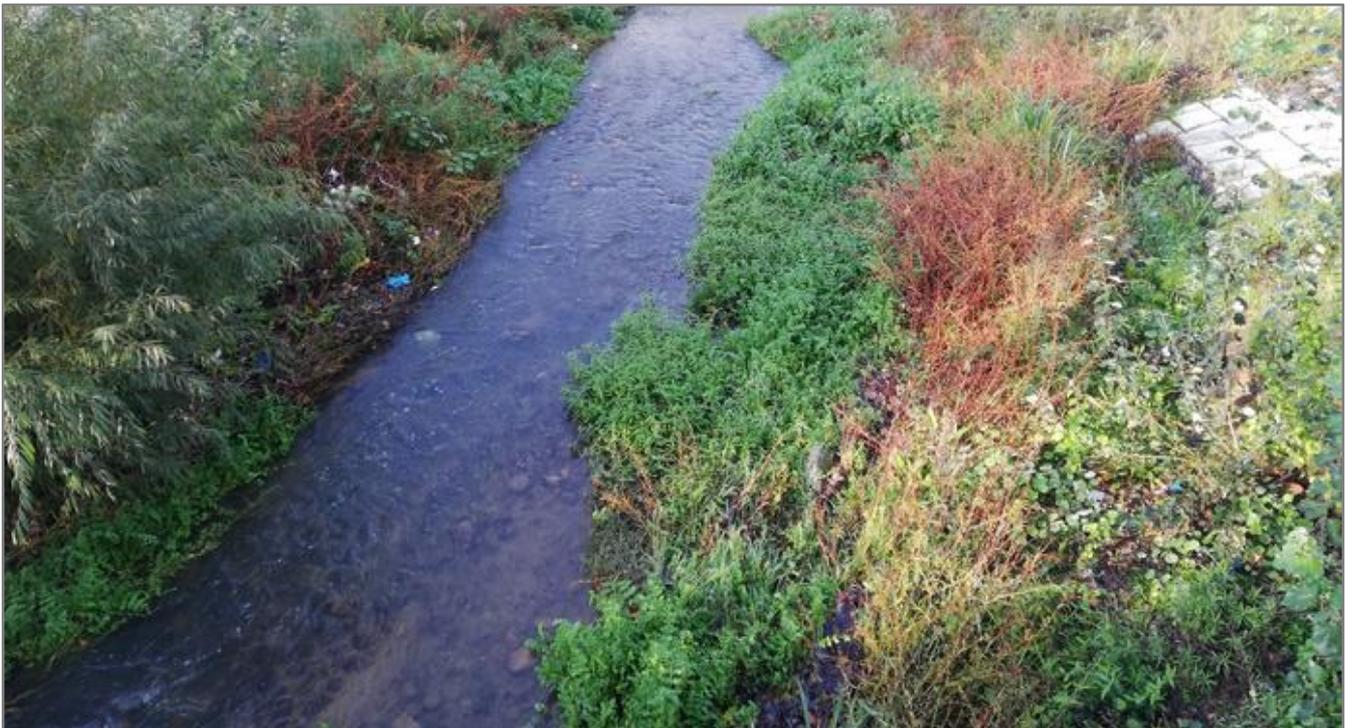
Figure 5-4: Swift turbulent flow immediately downstream of the bridge.

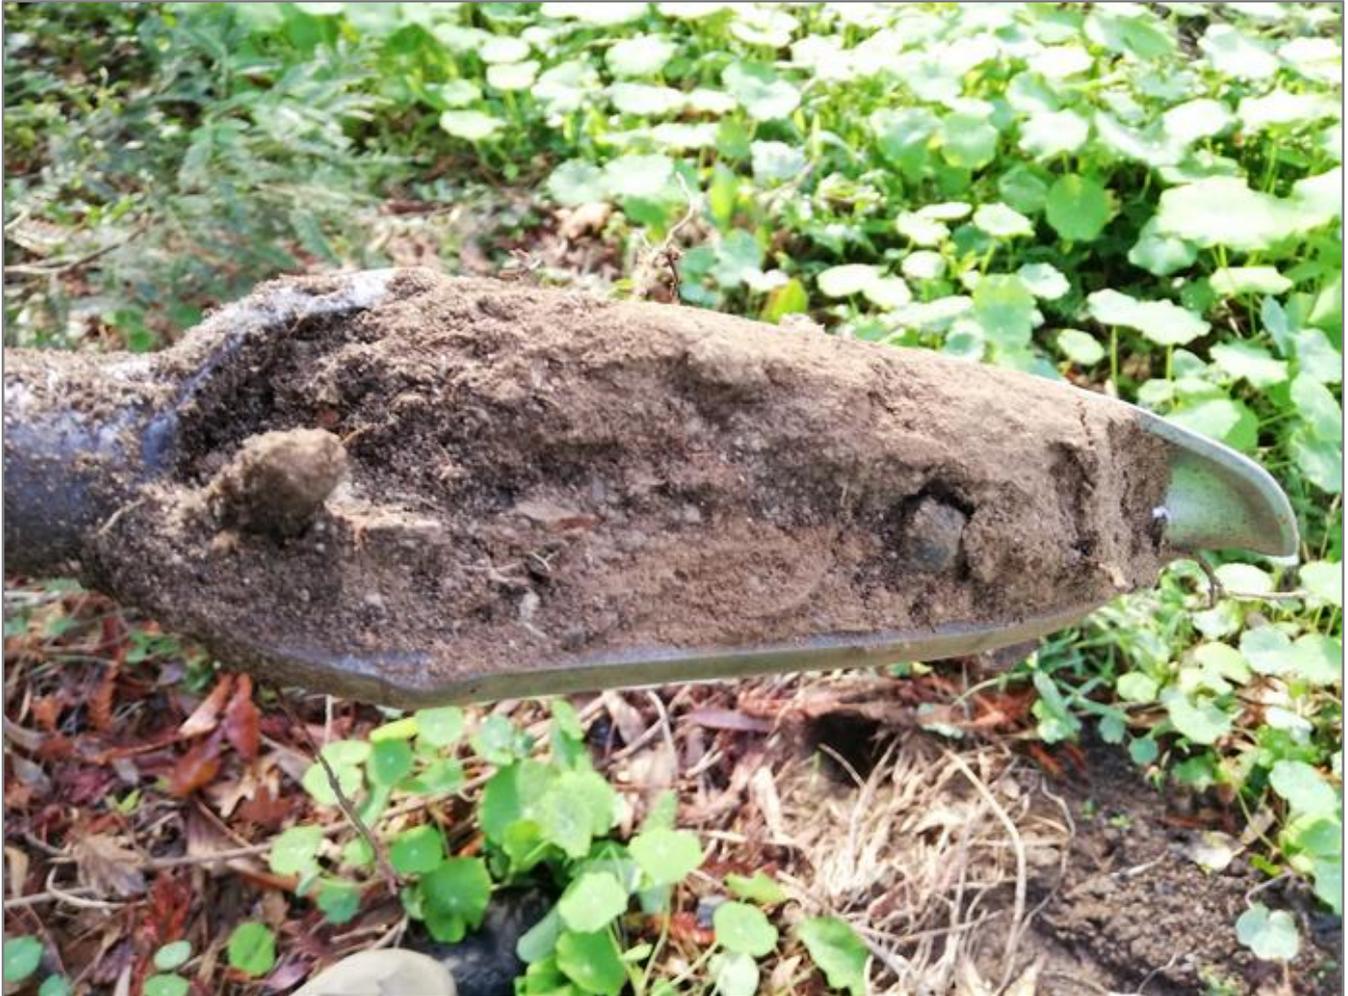
Figure 5-5: A soil sample taken by hand auger from the top of the west bank of the river upstream of the bridge consisting of deep, unconsolidated alluvial sediments.

The riverbanks are high and steep, generally extending over 2 m above the river channel. The banks were augered using a hand auger and found uniformly to consist of loose, unconsolidated alluvial sediments (see Figure 5-5). Wetland soil indicators were absent from all augered soil samples which confirms that unlike many rivers in the area, this reach of the Plankenbrug River is a true river and not a channelled valley bottom wetland.

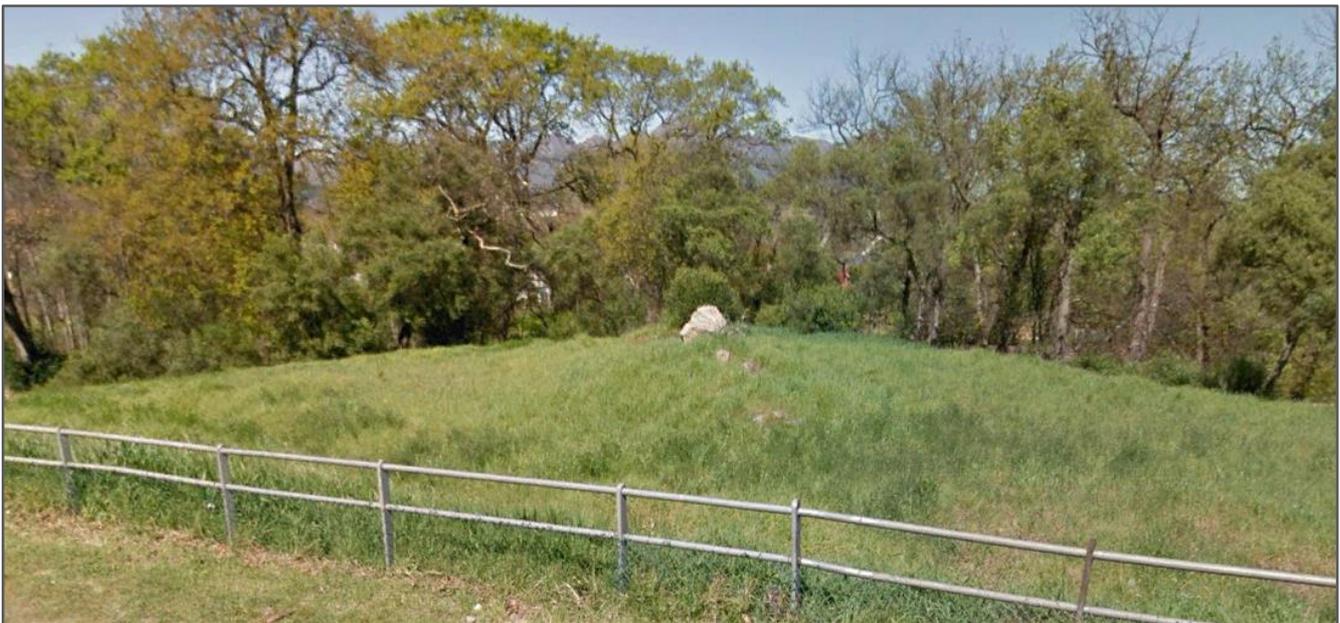
Figure 5-6: The grassy knoll indicated as wetland downstream of the Adam Tas Road bridge. The trees on the slopes below the grassy knoll are alien invasive species including *Quercus robur* and *Populus candescens*.

The second wetland that falls outside of the approximate project footprint is indicated immediately downstream of the Adam Tas Road Bridge, approximately 140 m downstream of the Distillery Road bridge. During the site visit, the site was found to be a grassy knoll dominated by the alien invasive *Pennisetum clandestinum* (see Figure 5-6) which occurs readily both within or without wetland soils and hydrology. The area was most notably found to be at least three metres higher than the river, elevated even above the road, and set back by approximately 30 m. It is unlikely that a wetland occurs at this location given the terrain. The elevation and distance from the river furthermore negate any potential water quality or hydrological impact from the proposed project even if wetland conditions do exist, since river water is highly unlikely to reach this area even under the most extreme flood conditions. Further assessment was therefore deemed unnecessary.

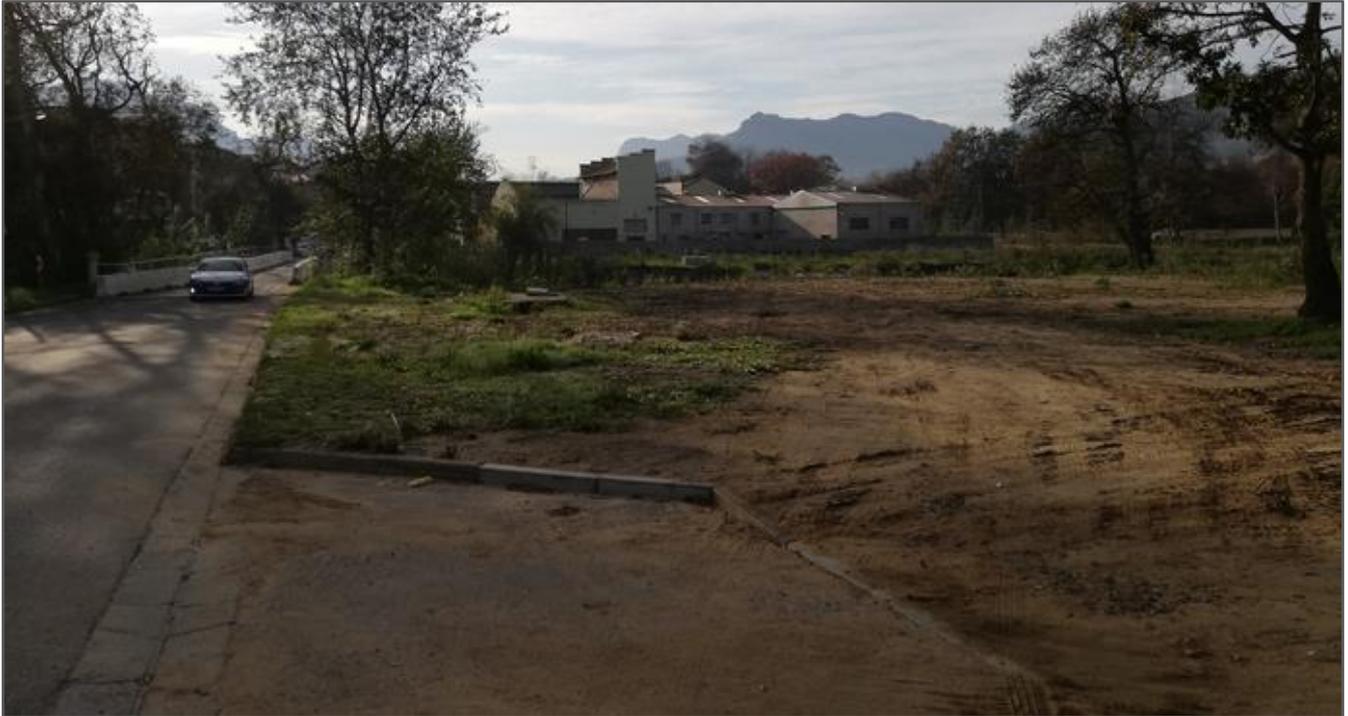
Figure 5-7: The area indicated by the WCBSP (2017) as CBA1 wetland and terrestrial immediately downstream of the Distillery Road bridge, with no remaining natural vegetation. The pipeline that was replaced lies in the middle of this area and the soil is recently disturbed and compacted.

The two wetland areas indicated within the project area are located within the previous severe disturbance footprints related to the pipeline replacement and earlier construction work. The southern potential wetland area was devoid of hydrophytic vegetation and exhibited only hard, compacted terrestrial soils that were difficult to auger (see Figure 5-7). Soils were dry despite the season and where limited augering depth could be achieved and would not remain within the auger head.

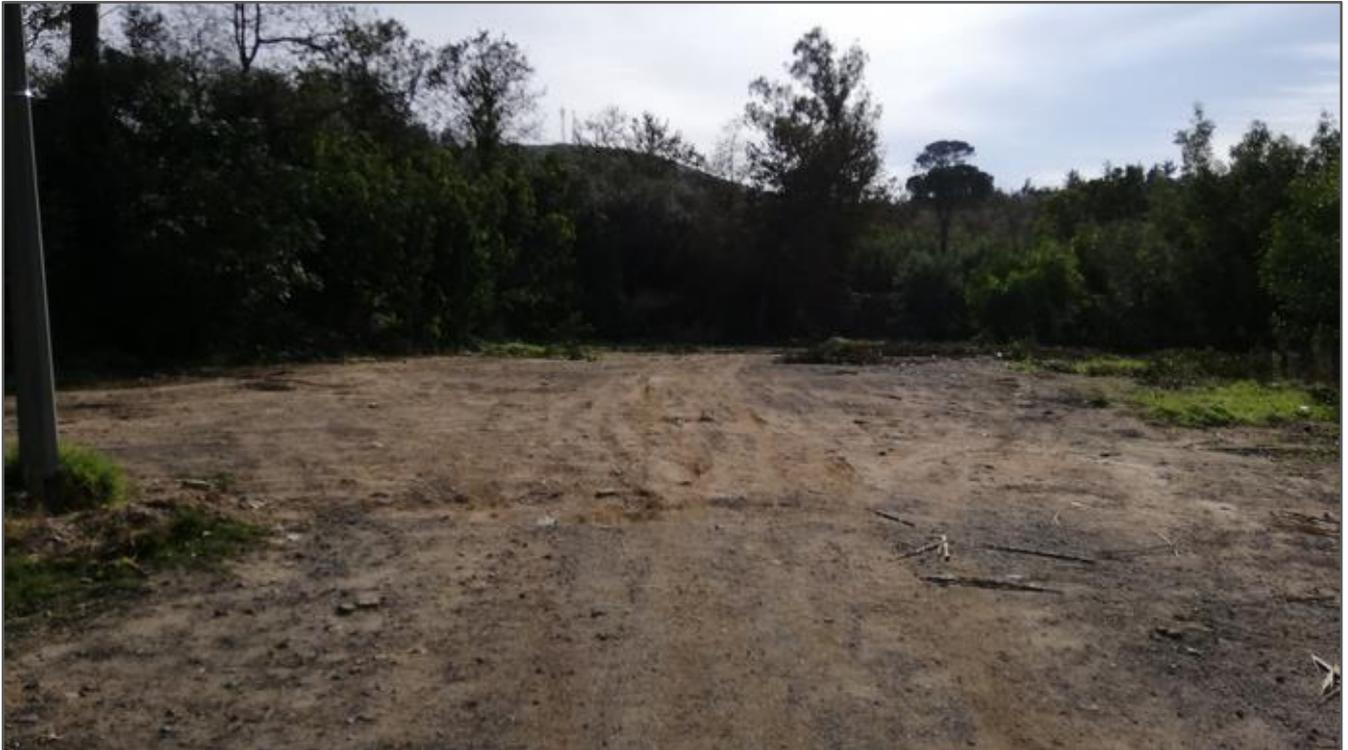
Figure 5-8: The area indicated by the WCBSP (2017) as a terrestrial and wetland CBA1 upstream of the Distillery Road bridge. This area was used during replacement of the pipeline as a staging and stockpiling area.

The northern potential wetland area was largely similar, coinciding largely with the levelled platform and its raised edge. It exhibited dry, compacted soils on the raised platform that could also not be augered effectively. The only vegetation consisted of sparse *Pennisetum clandestinum* between young *Eucalyptus cameldensis* (both alien invasive species) along the edge of the levelled platform (see Figure 5-8).

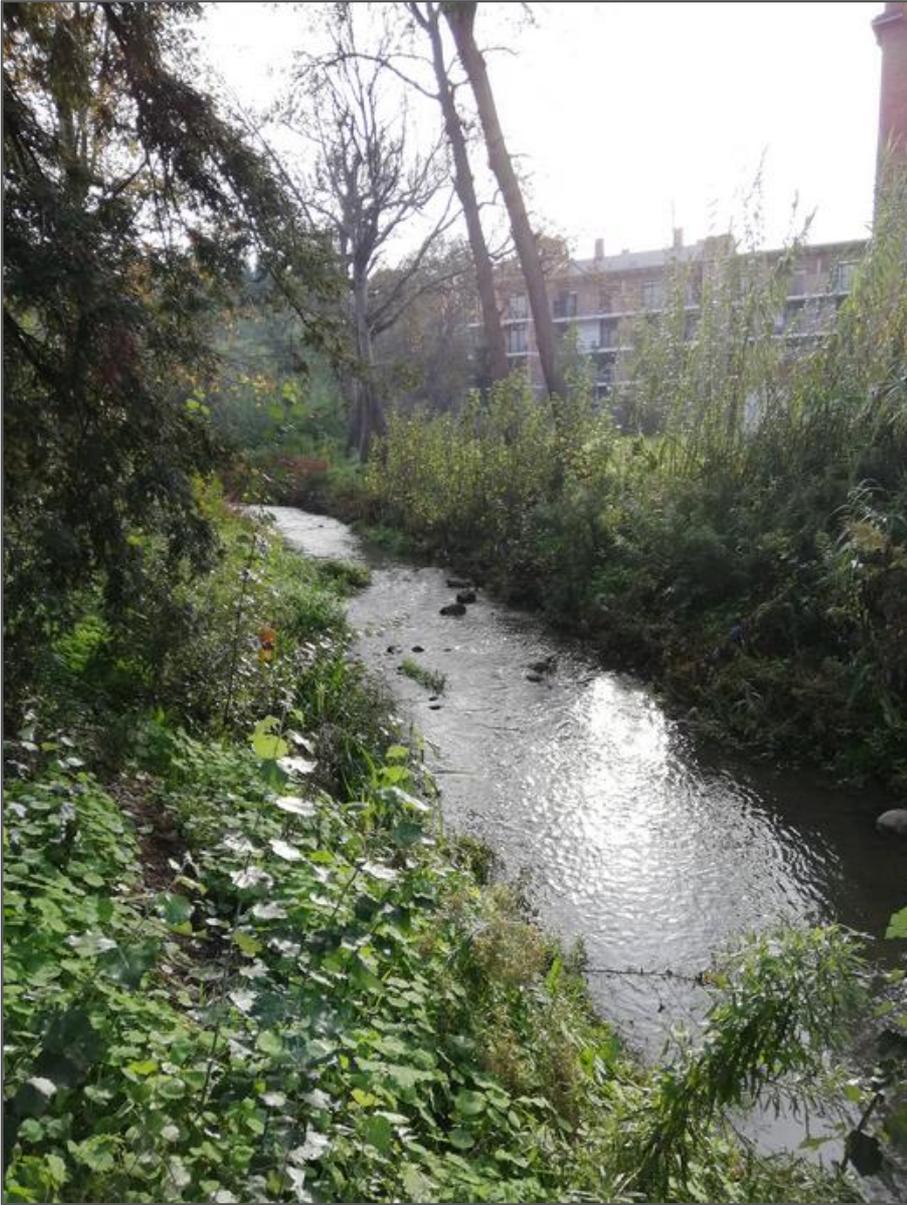
Figure 5-9: Marginal vegetation upstream of the bridge dominated by *Commelina bengalensis*, *Arundo donax*, *Persicaria lapathifolia* and *Populus candescens*.

The top of the east bank upstream and both banks downstream of the bridge is levelled and compacted with sparse terrestrial pioneer vegetation dominated by *Cynodon dactylon* and *Pennisetum clandestinum* grasses. Occasional *Quercus palustris* (Spanish oak) are also present scattered within the disturbed terrestrial area downstream of the bridge on the west bank. No vegetation was confirmed present that corresponds to the critically endangered historical renosterveld terrestrial vegetation type and given the degree of past disturbance, infilling and compaction, the indigenous vegetation and its seed bank is most likely entirely lost. There is therefore no sign of terrestrial vegetation that may correspond to the terrestrial CBA1 areas indicated by the WCBS (2017) and no terrestrial vegetation impact is expected. Examples of aquatic and riparian vegetation are provided in Figures 5-9 to 5-12. Examples of the terrestrial areas are indicated in 5-5 and 5-6 above.

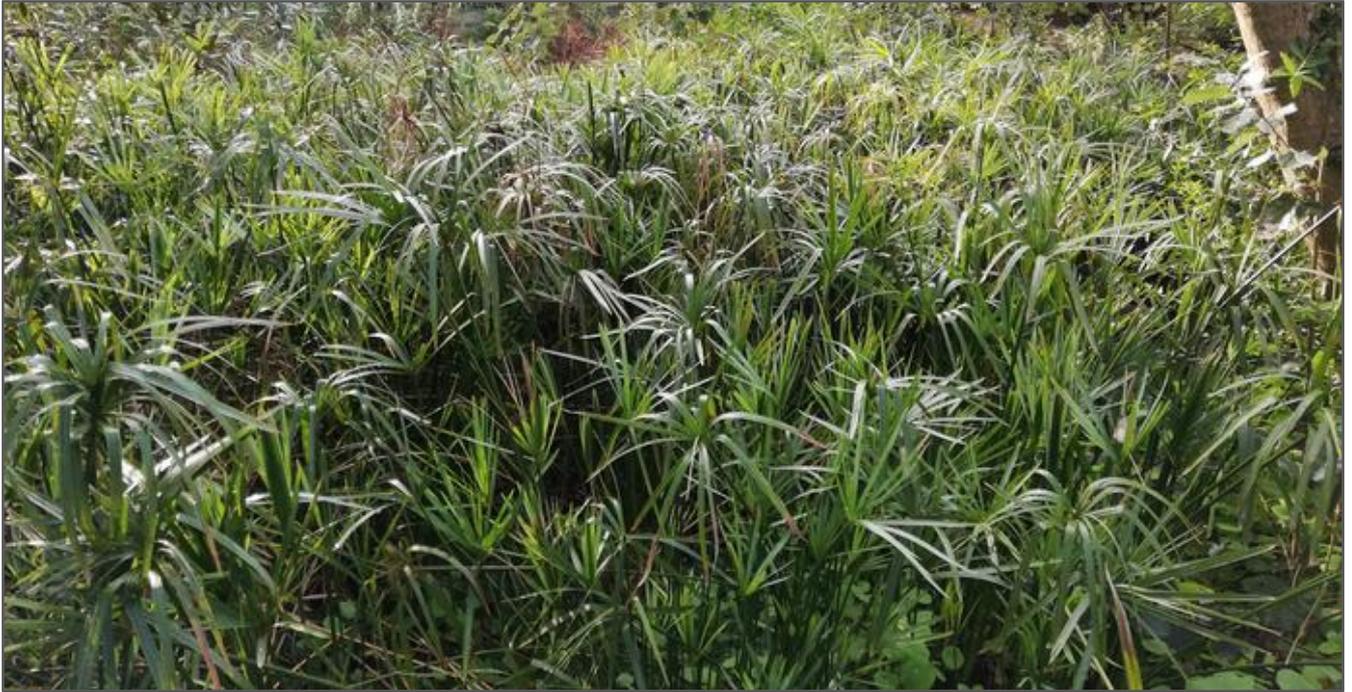
Figure 5-10: A patch of *Cyperus textillis*, on the west bank upstream of the bridge.

The river has a significant riparian zone much broader than the riverbank in places. Upstream of the bridge on west bank, the riparian zone includes a mix of alien and indigenous trees. Here, the understory is dominated by the alien invasive *Tropaeolum majus* and *Pennisetum clandestinum*, with a single patch of indigenous *Chasmanthus aethiopica*. The canopy was dominated by the indigenous *Olea europa ssp. africana* (wild olive) and the alien *Populus candescens* (poplar), with occasional *Eucalyptus camaldensis* (red river gum) towards the terrestrial extreme of the riparian zone.

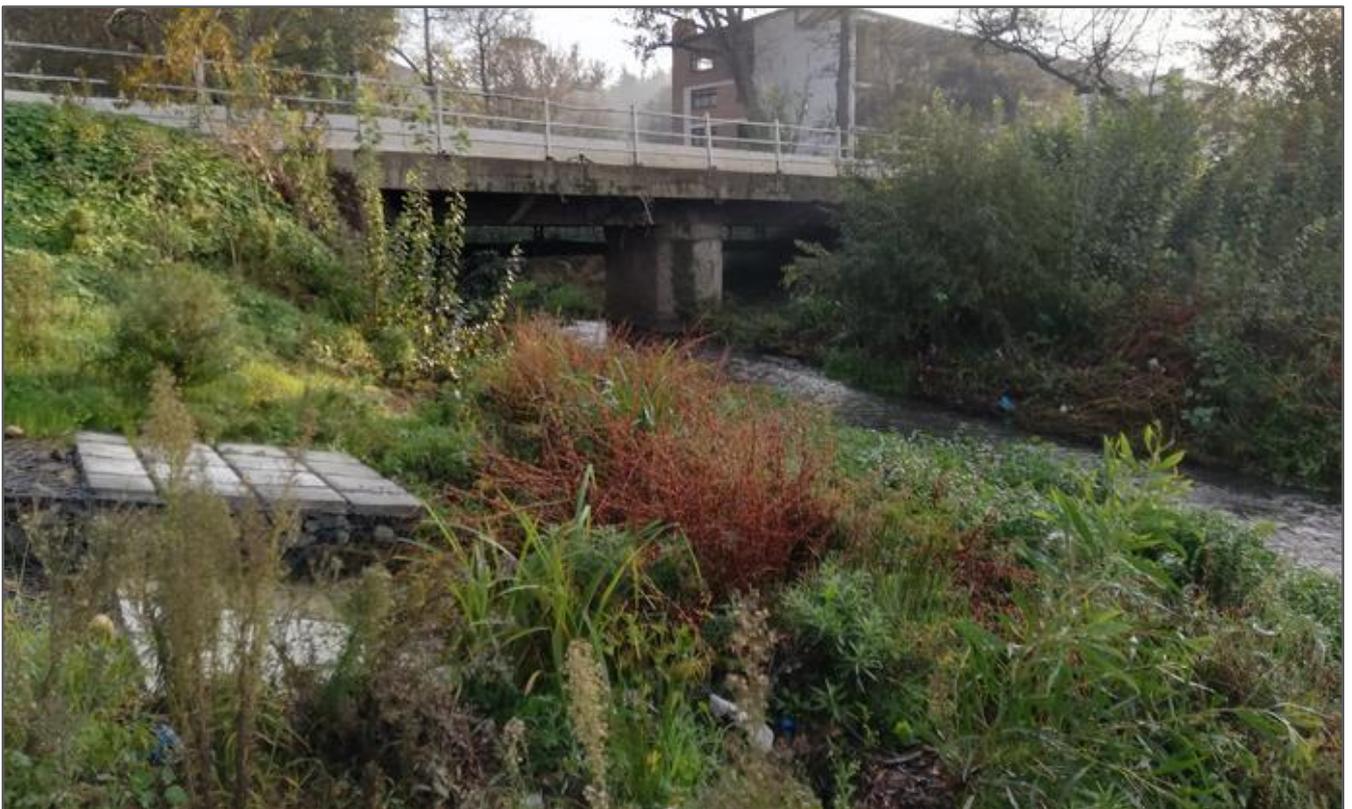
Figure 5-11: Stream bank vegetation downstream of the bridge in the vicinity of the recently replaced pipeline including *Cyperus dives*, *Cyperus textillis*, young *Populus candescens* and *Persicaria lapathifolia*.

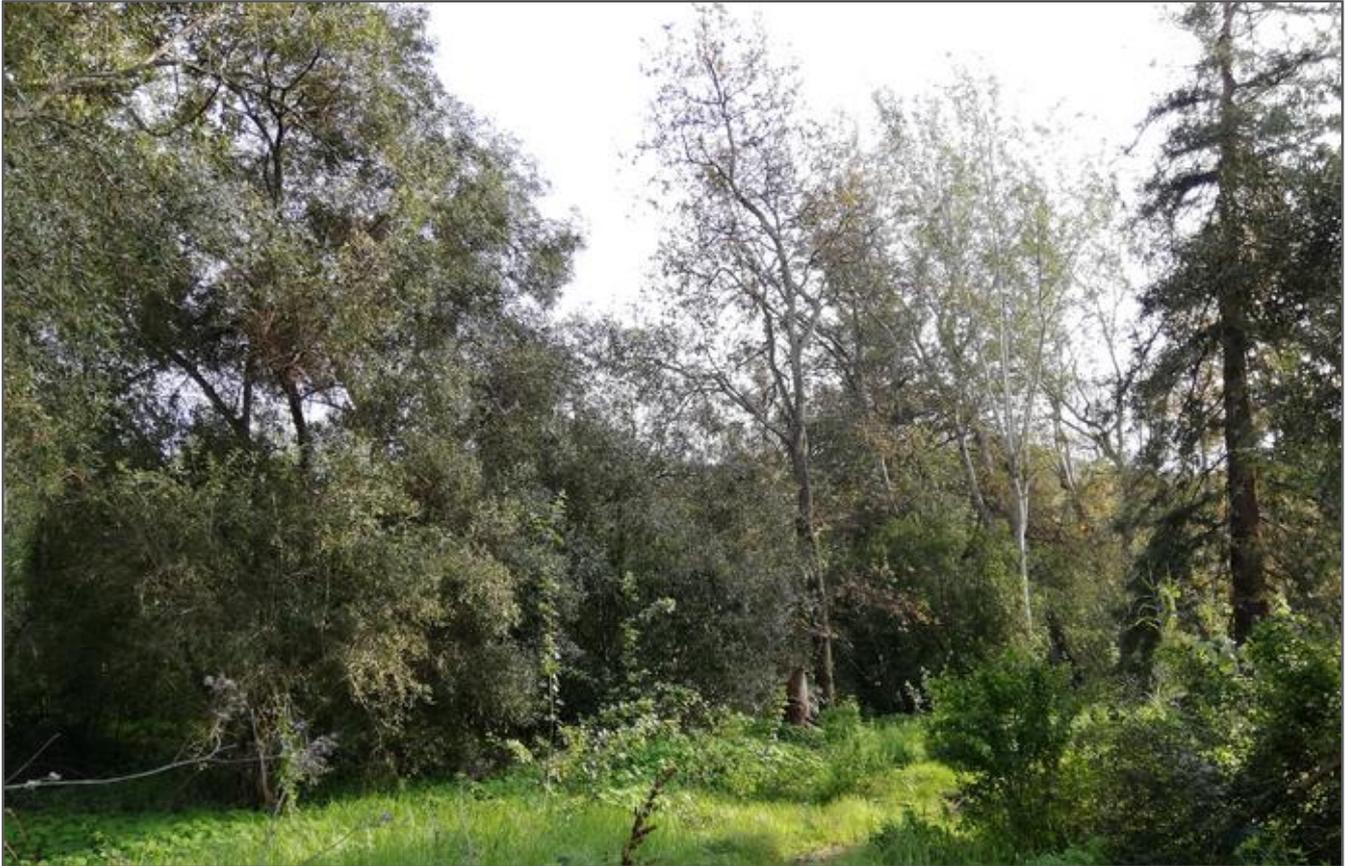
Figure 5-12: Riparian zone on the west bank of the river, north of the bridge dominated by *Tropaeolum majus*, *Pennisetum clandestinum*, *Olea Europa ssp. africana* and *Populus candescens*.

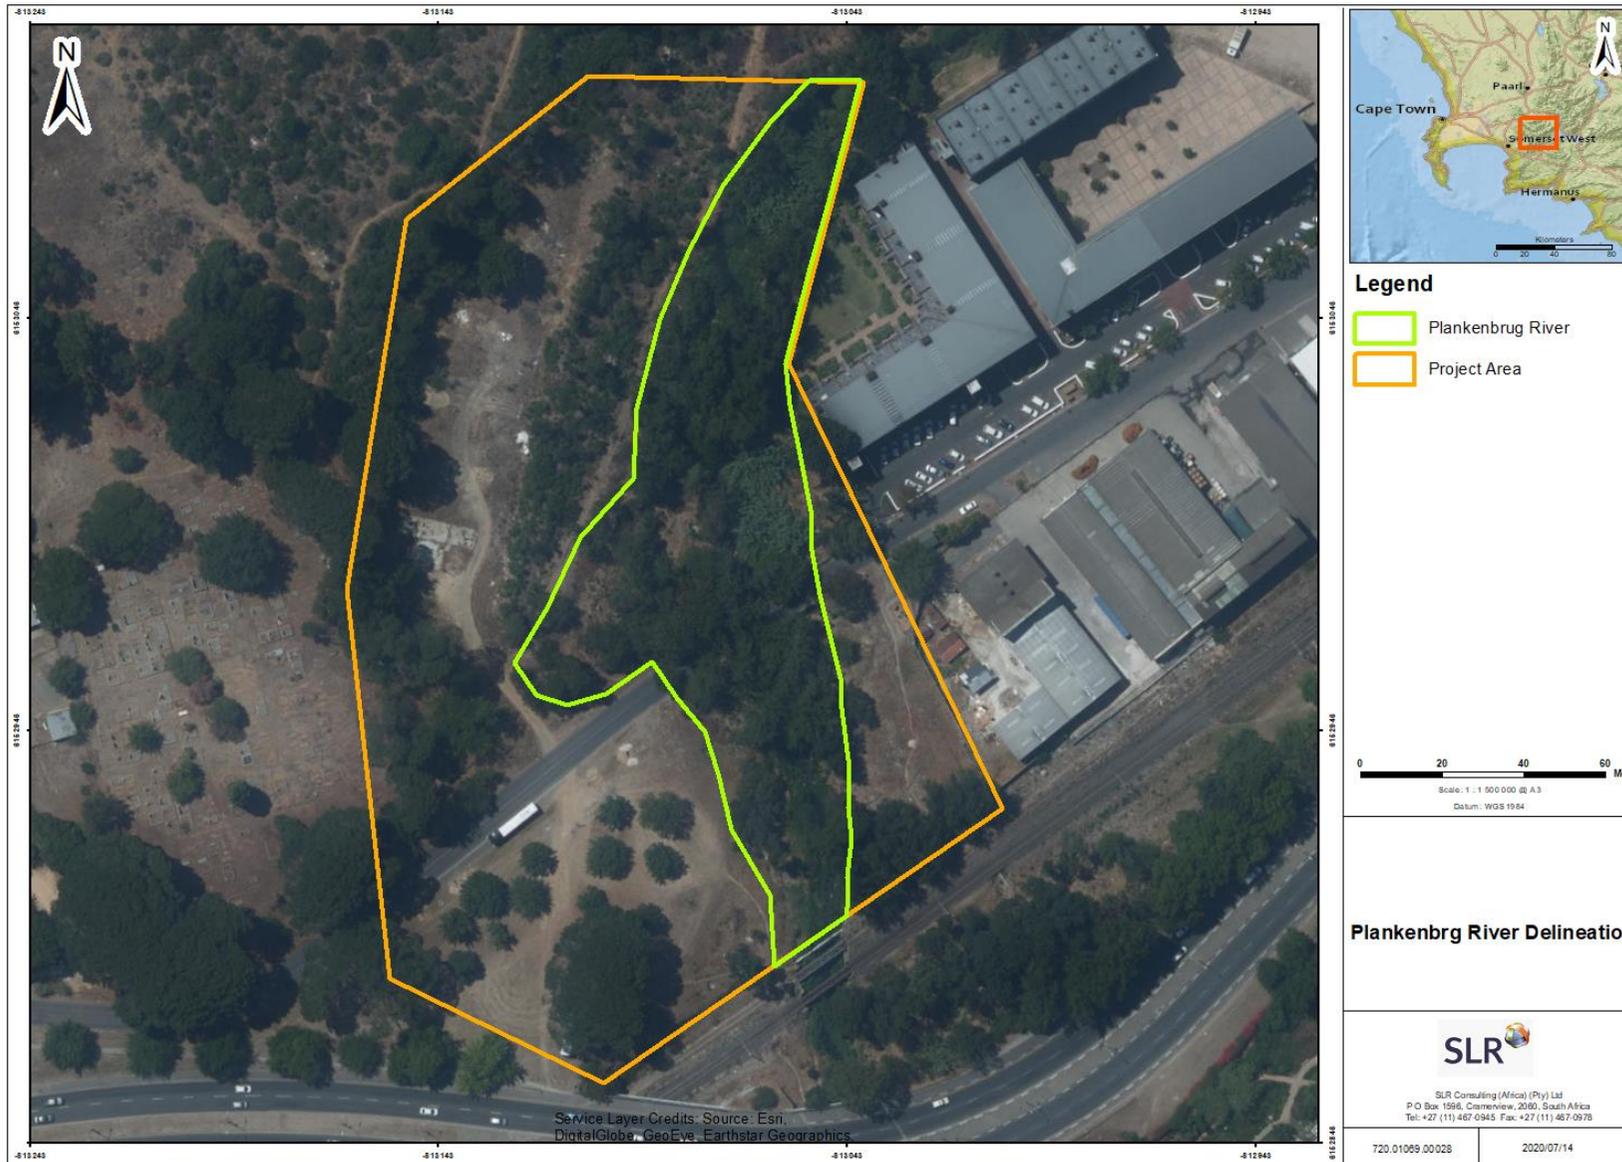
Figure 5-13: Delineated portion of the Plankenbrug River within the project area.

Of the watercourses indicated within the project area, only the Plankenbrug River was found to be present. The river was delineated by means of the DWAF (2008) delineation guidelines using a combination of alluvial soils, riparian vegetation and topography. The delineated watercourse covers approximately 0.79ha and is presented in Figure 5-13 below.
